## CASE STUDY

# ATLAS COPCO RD20 REFURBISHMENT

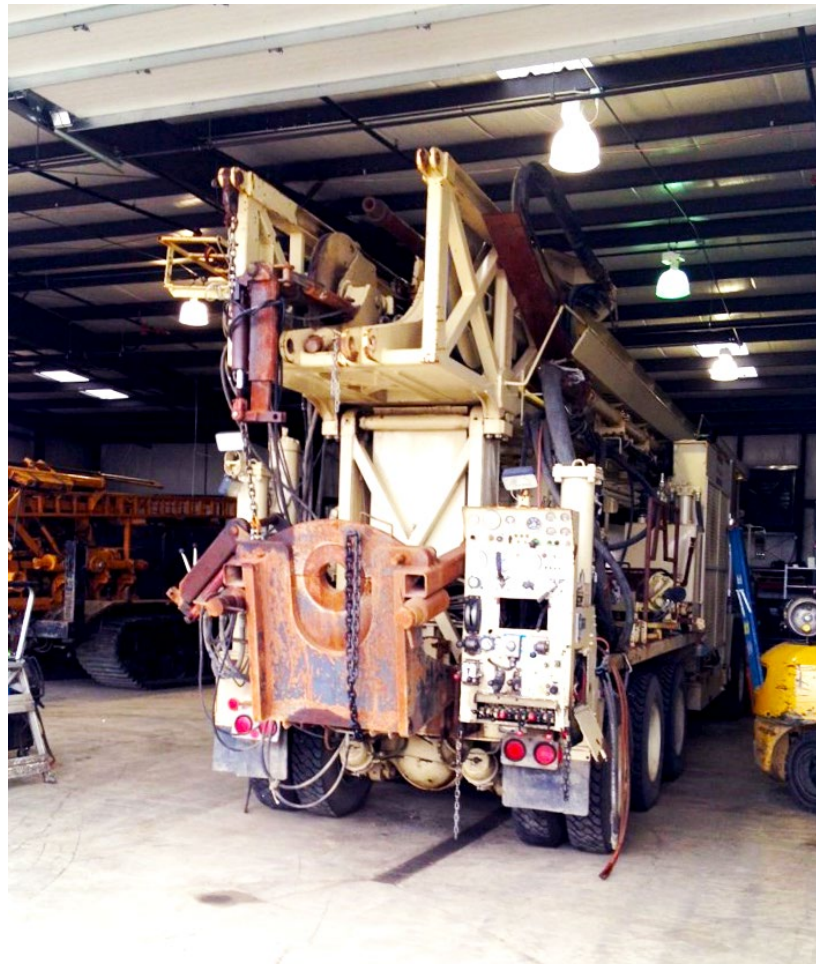
**Before:** The Atlas Copco RD20

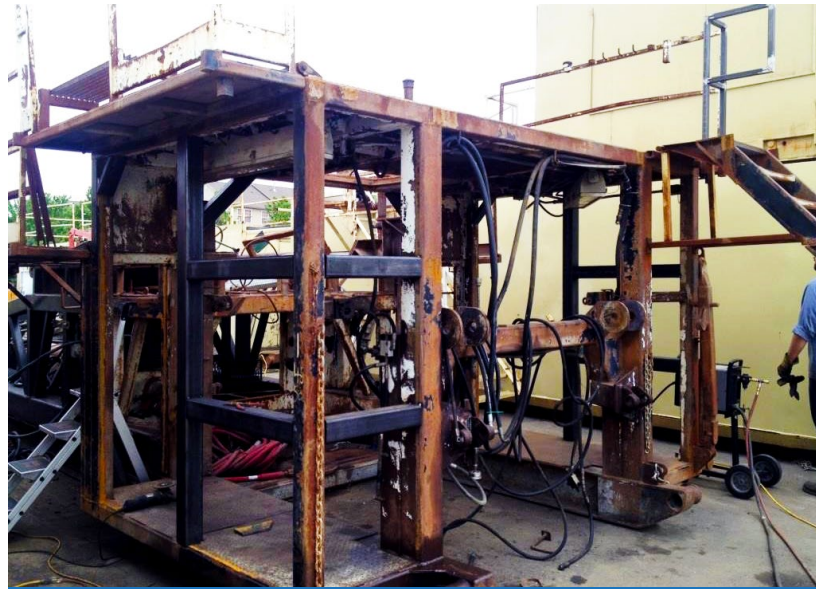
**Before:** Front View of the Substructure

| <input type="checkbox"/> Cleaned and emptied stations of miscellaneous items | <input type="checkbox"/> Re-sheeted top deck of substructure, cut off/welded on new diamond plate & replaced mesh |
| <input type="checkbox"/> Repaired oil leaks, cord holders, fuel pump motor, hinges, lights & doors | <input type="checkbox"/> Painted substructure, mud mixer, fuel station, dog house, rod loaders, and generator station |

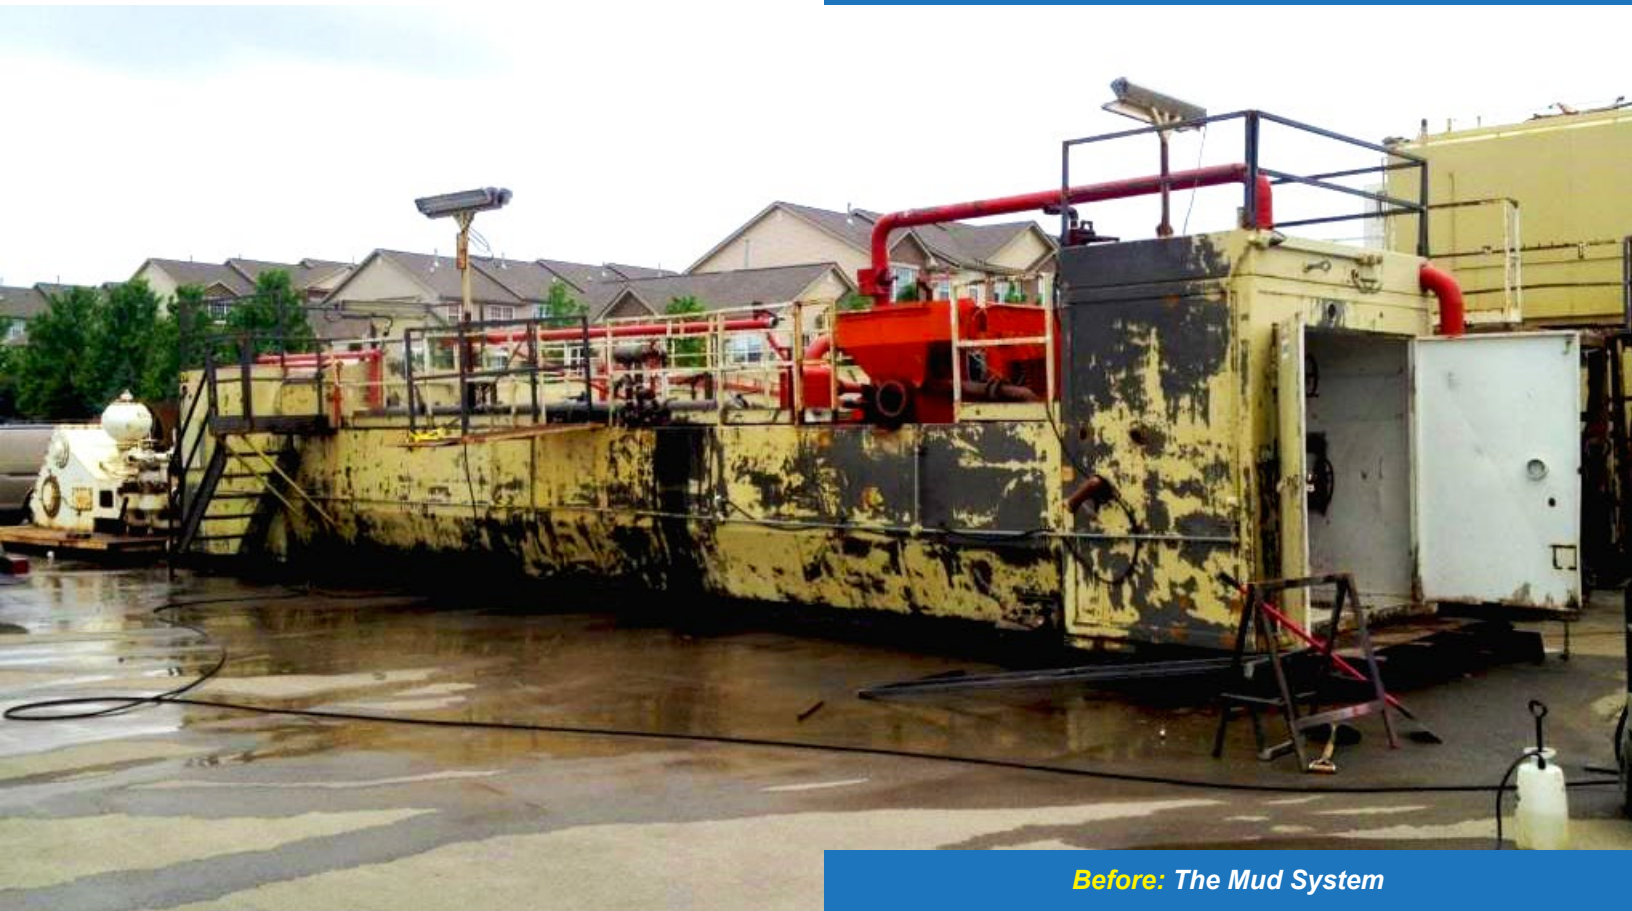
**Before:** The Mud System

| <input type="checkbox"/> Freed ball valves | <input type="checkbox"/> Adjusted and applied new seals for clean out doors on mud mixer |
| <input type="checkbox"/> Replaced motor mixer and damaged SO cord going to motor | <input type="checkbox"/> Installed new paddle in tank for mud mixer & repaired shaker chute |

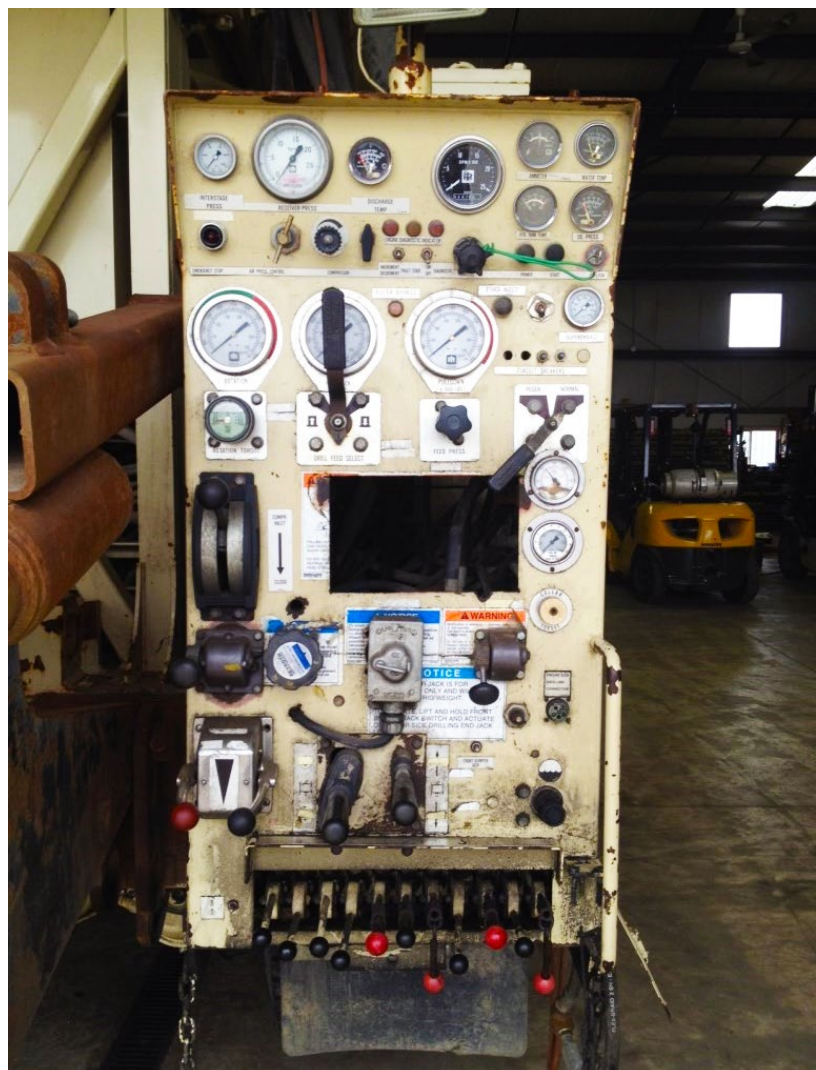
**Before:** The Control Panel

| <input type="checkbox"/> Replaced starters for fuel station, shaker, and mud mixer | <input type="checkbox"/> Updated control panel with explosion proof switches |

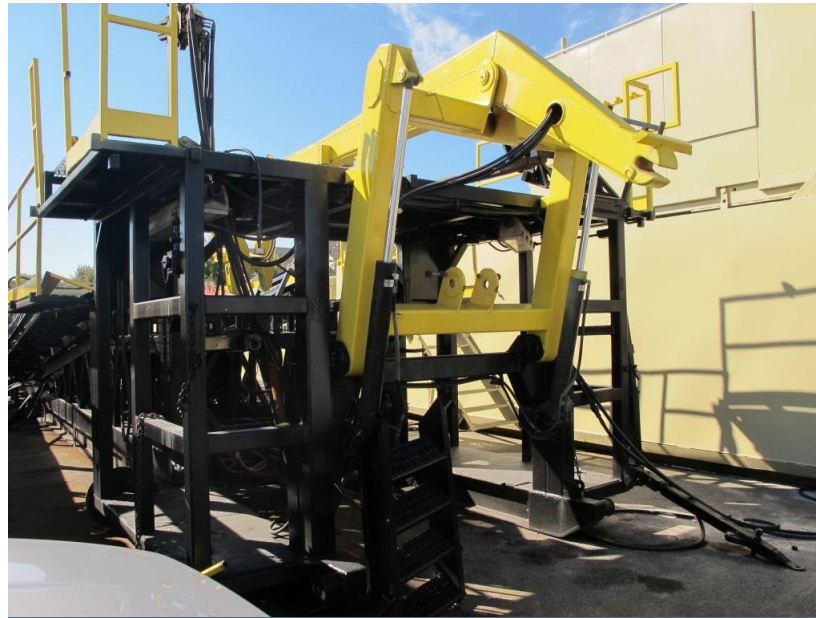
*After: Front View of the Substructure*

| <input type="checkbox"/> Hooked up hydraulic hoses and electric cables to test generator house, substructure, dog house, and mud mixer | <input type="checkbox"/> Manufactured new hand rails, 20ft. ramps and stairs |

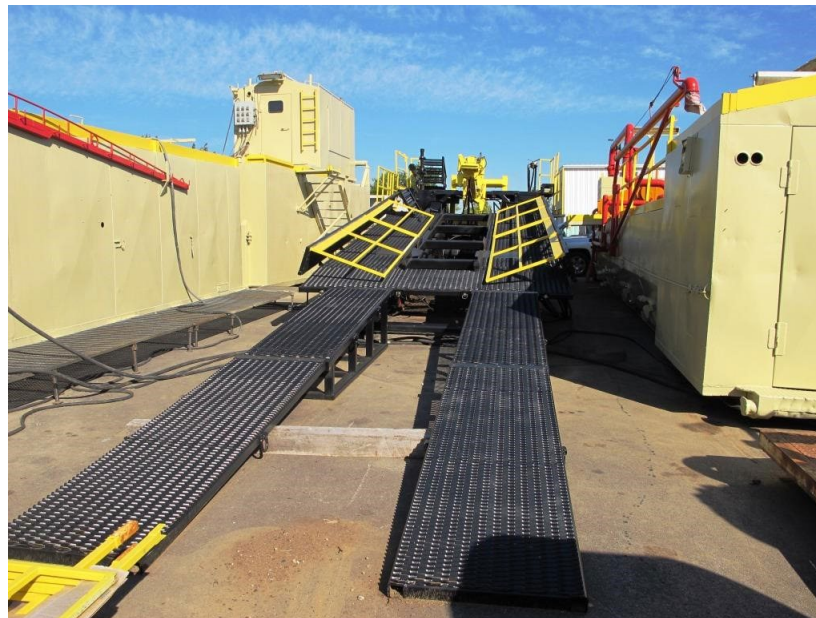
*After: Rear View of the Substructure*

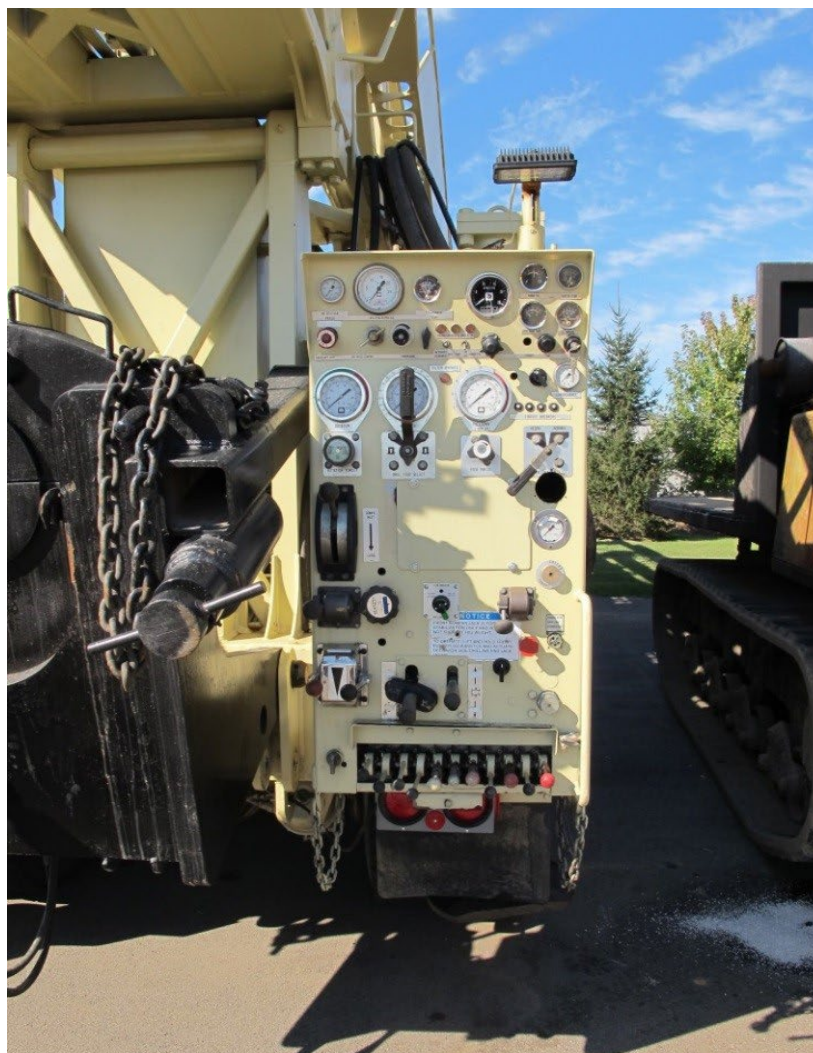
**After:** The Freshly Painted and Labeled Control Panel
